THAMES RIVER BASIN
SOUTHBRIDGE, MASSACHUSETTS

RESERVOIR NO. 3 DAM
MA 00691

PHASE I INSPECTION REPORT
NATIONAL DAM INSPECTION PROGRAM

SEPTEMBER 1979

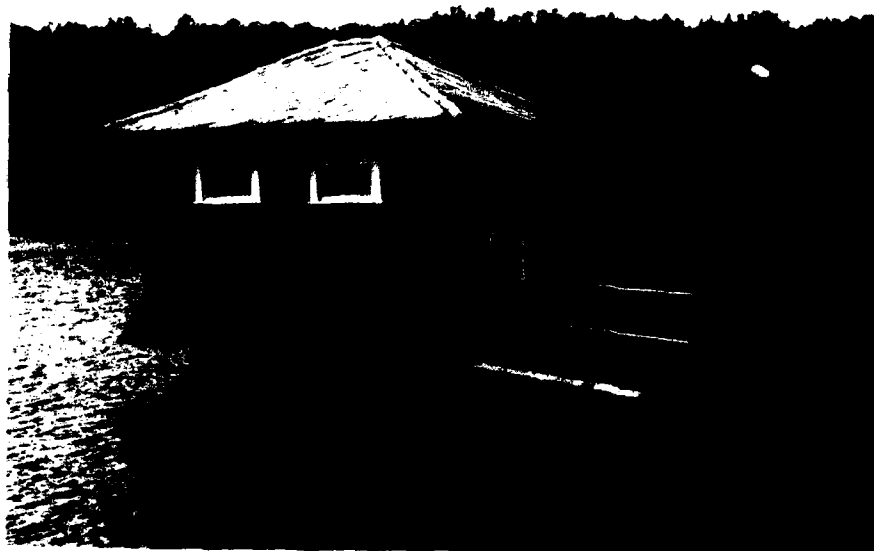
8. OUTLET WORKS GATEHOUSE.
